EVALUATION OF SEA-WATER REVERSE OSMOSIS MODULES FOR SINGLE-PASS SHIPBOARD DESALINATION SYSTEMS

PROPULSION AND AUXILIARY SYSTEMS DEPARTMENT
Annapolis
RESEARCH AND DEVELOPMENT REPORT

March 1974

Report 27-717

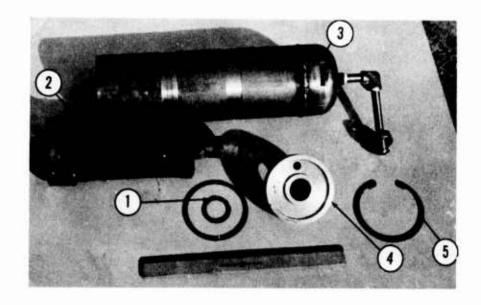
Figure 2
Reverse Osmosis Module Disassembled for Inspection

At 490 hours of operation, one of the diaphragms in the duplex high-pressure pump ruptured, allowing hydraulic oil to seep from the pump into the sea-water system. When the rupture was discovered, the unit was secured and the module disassembled for visual inspection, figure 2. The actual membrane fibers were not visible because of a nonremovable fabric covering around the fiber bundle. However, the pressure case was found to have a thin coating of oil on its inside walls. Also, the water remaining in the case had a high concentration of iron

oxide particles. The fabric covering the fiber bundle had a brown hue, indicating that the membrane fibers had been exposed to a large amount of iron oxide, found previously to be detrimental to RO operation.

The module was reassembled and flushed out (in a manner similar to the flushing procedure previously described with module S-52) with a 0.5% citric acid solution to clean out the iron oxide and a 0.5% Biz home-laundry presoak solution to dissolve any remaining oil from the module.

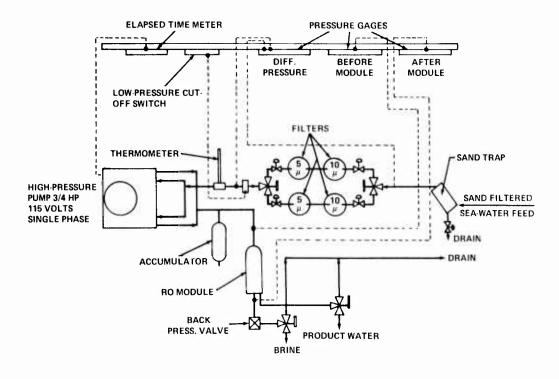
At approximately 475 hours operating time it was found that the accumulator was contributing a large amount of iron oxide to the system. Since iron oxide can foul the membrane and seriously reduce the product rate, the accumulator was removed from the position shown in figure 5 and placed between the RO module and the back-pressure regulator. With this scheme, corrosion products from the accumulator could not pass through the module. No change in the attenuation of pump pressure fluctuations was apparent as a result of the repiping of the accumulator.

Figure 5 - Natural Sea-Water Reverse Osmosis

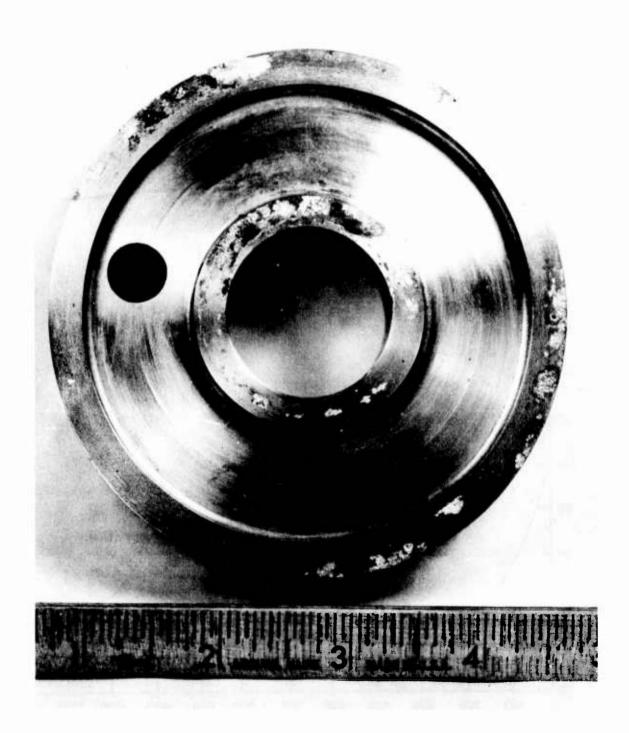
During the operation of RO module S-52 on synthetic sea water, it was found that iron oxide particles from stainless steel piping fouled the RO membrane and reduced the product rate significantly. Since the iron oxide could accumulate in the system, due to the recirculation mode of operation, the sea-water solution was periodically changed. The degree to which corrosion did occur is demonstrated in figure 7 which shows the 316 stainless steel permeate header with deep pitting on the sealing faces. The faces, which were sealed with a gasket material, were in contact with product water containing only 100 to 200 p/m TDS. Apparently the amount of chlorides in this water was high enough to cause crevice attack after the water had permeated the gasket.

Figure 7
Reverse Osmosis Module Permeate Header
Showing Evidence of Corrosion

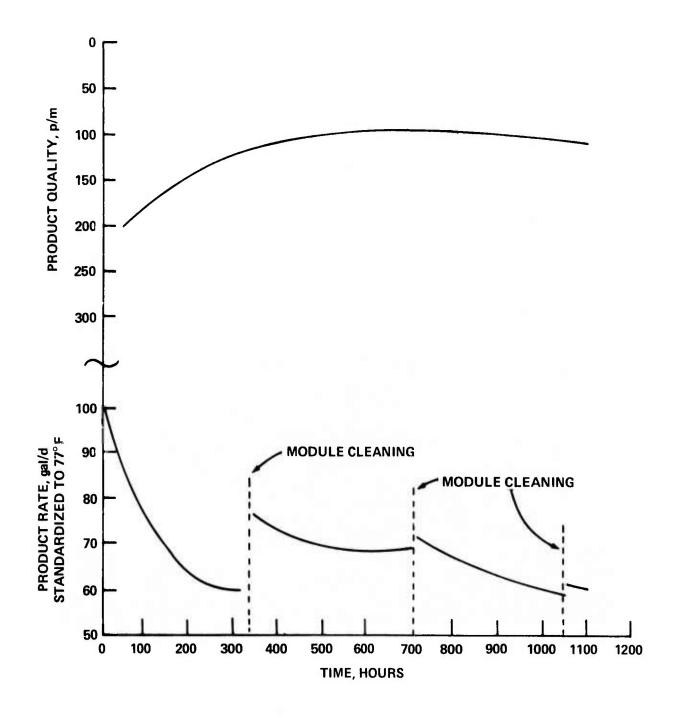
Figure 8 shows the performance of RO module S-52 on synthetic sea water. As can be seen from the top curve in the graph, product quality varied between 100 and 200 p/m. On the lower portion of the graph is a plot of the product rate (gal/d) versus operating time (hours). It was noticed after 373 hours of operation that the product rate had declined markedly. It was suspected that this decrease was caused by iron fouling on the membrane surface and not membrane compaction caused by water pressure. Therefore, the membrane was cleaned by back flushing the module with a 1.0% citric acid solution, which had been found effective by other investigators in cleaning iron fouled membranes. Backflushing was accomplished by feeding the cleaning solution to the module brine discharge port for 2 hours as shown in item (a) of figure 9. The solution being circulated took on a deep yellow color, an indication of dissolved iron. This was followed by a 0.2% citric acid solution fed through the module in the normal flow direction, item (b) of figure 9. Finally, the module was flushed with distilled water for 15 minutes. It can be seen from figure 8 that the product rate was partially restored by the cleaning procedure.

Again, after 728 hours of operation, the RO module was backflushed in the manner previously described. In this instance, the backflush procedure was less successful since the product rate improved only very slightly. The cleaning procedure was attempted again after 1050 hours of operation but again only a small improvement in the module product rate was noted after cleaning.

Figure 8
Evaluation of Reverse Osmosis Module S-52
on Synthetic Sea Water at NSRDC

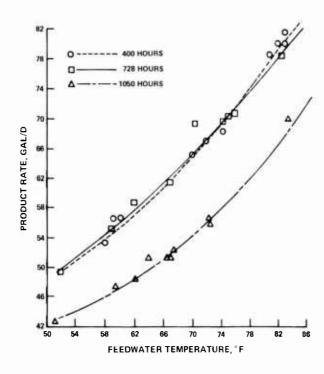
It is apparent from figure 10 that the product rate is a strong function of the feedwater temperature, which fact is well known among other RO investigators. It appears that the citric acid cleaning of RO iron-fouled membranes was only partially effective in restoring membrane surfaces.

Figure 10 - Product Rate Versus
Feed Water Temperature for Reverse Osmosis
Module S-52 at Three Operating Times

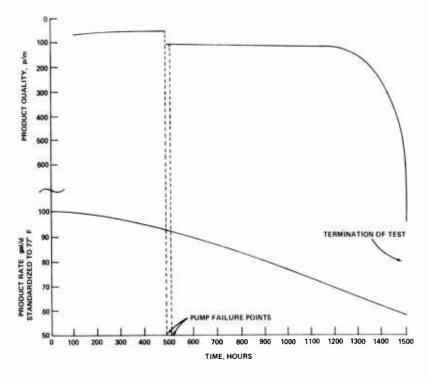
Figure 11 is a graph of the performance of RO module S-53 on natural sea water. As seen in the figure, performance was satisfactory for 1200 hours until the product quality began to drop precipitously. The product rate showed a steady decline throughout the test period. A combination of several influencing factors including membrane compaction, hydraulic oil fouling, iron fouling, and bacterial action are suspected to have caused the flux and product quality declines.

Checks of the feedwater, upstream of the RO module, revealed that bacterial activity increased substantially during the later stages of the test. The product water quality decline beginning at 1200 hours of operation is suspected of being attributable to holes in the membrane caused by increasing bacterial attack.

If holes were to develop in the membrane, a concommitant increase in product rate and decrease in product quality would follow. This unusually steady decrease in product rate is attributed to membrane fouling from slime given off as bacterial waste products. This effect may have caused the channeling of feedwaters through the fiber bundles resulting in further poor performance. Attempts to clean the RO module with a biocide (copper sulfate), citric acid, and Biz presoak in the flushing procedure resulted in only partially restoring product water rate and quality.

In summarizing the performance of RO module S-53 on natural sea water, performance declined noticeably at 350 and 1200 hours of operation. The product water quality decline at 350 hours was attributed to hydraulic oil or cleaning solution effects on the membrane. The drastic product water quality decline beginning at 1200 hours of operation was attributed to biological attack on the cellulose triacetate membrane. The steady decrease in product water rate was probably a result of several factors: hydraulic oil fouling, bacterial waste product fouling, and membrane compaction.

Figure 11 - Evaluation of Reverse Osmosis
Module S-53 on Sea Water at
Wrightsville Beach, North Carolina
